DHANWAPUR 2

POND PROFILING

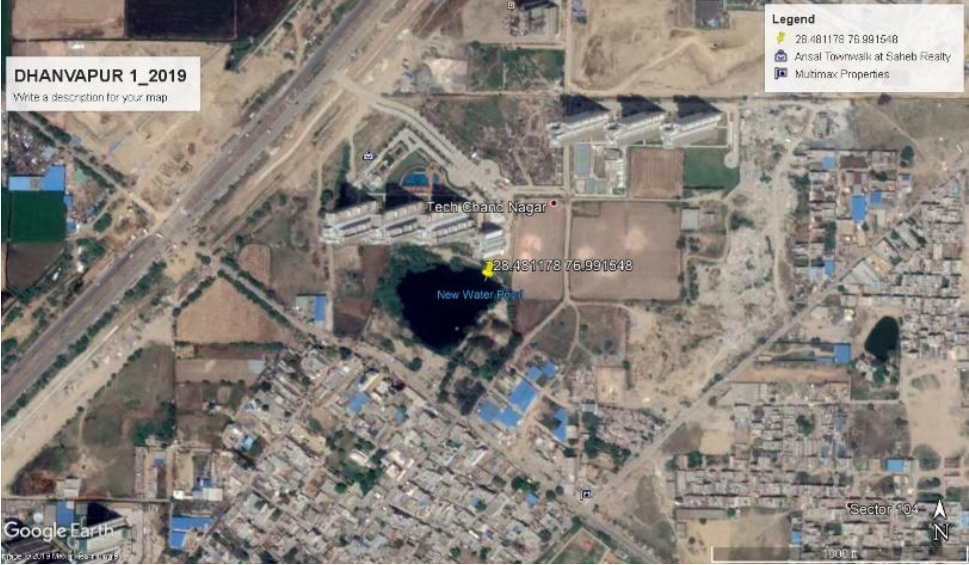
Site view of the water body

Currently, the pond is **polluted** due to continuous **discharge of municipal waste** from the village.

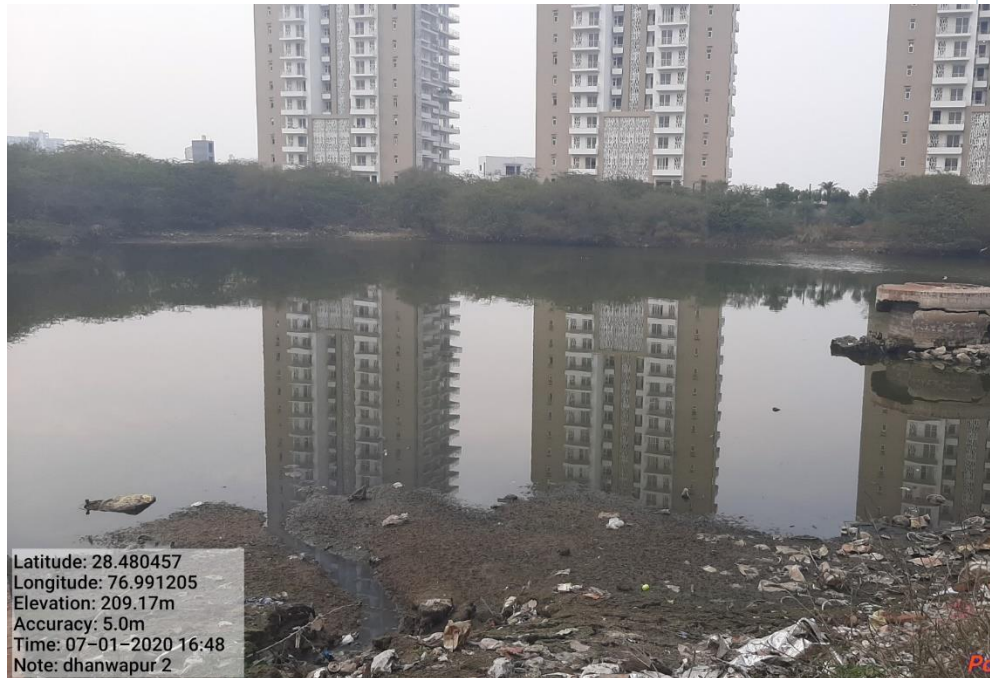
Geo tagged image of water body

Ownership of land	MCG
Khasra number	149
Landscaping around water body	<ul style="list-style-type: none"> • Major part of the water body is fairly clean. • 4 nos. existing wells can be seen within the water body. • Water body can be accessed from two sides only. The other two sides are blocked by heavy vegetation on one side and municipal boosting station on other. • Agricultural land on one side. • Presence of occasional aquatic life including birds. • Slow encroachment by filling the land with C&D waste is seen over the past few years.
Free space around water body	3000sqm
Can the water body be used as active urban/public space	Yes, the water body can be used as urban/public space.
Are there any construction activities going on near the water body	There's construction of high rise residential building going on near the water body.

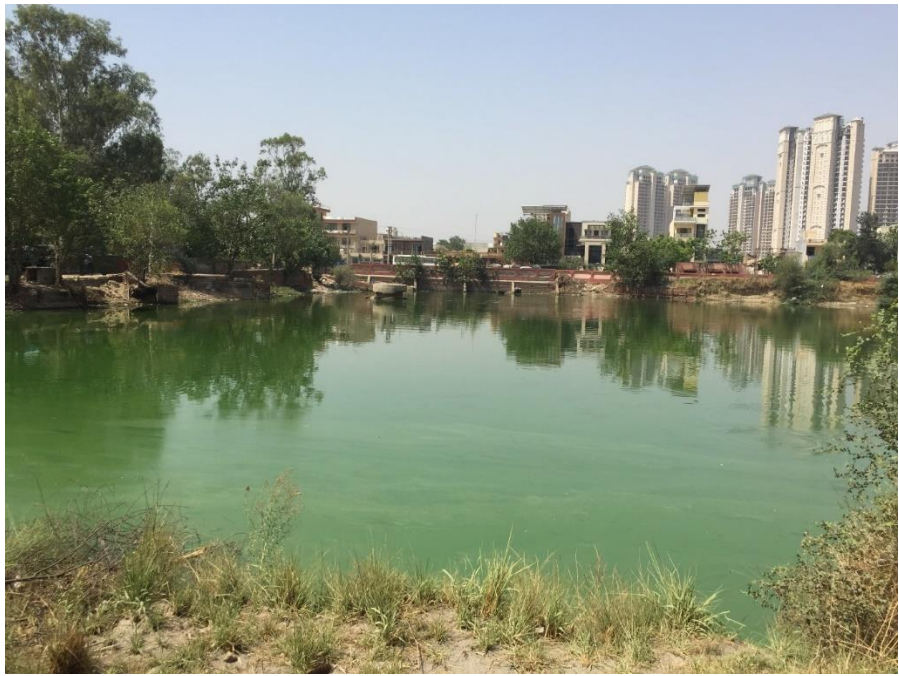
Does solid waste dumping takes place near the water body? (Organic/Non-Biodegradable)	Direct dumping of solid waste can be seen near the water body.
---	--

<p>Solid waste disposal in water body (religious offering/idol immersion)</p>	<p>Since the pond is located inside the village and has continuous discharge of municipal waste it is not used for any religious purpose.</p>
<p>Source of pollution in water pollution</p> <ul style="list-style-type: none"> • Municipal waste • Industrial effluent • Organic waste • Non biodegradable waste • Solid waste • In pond human activity • Cattle wadding • Agriculture runoff 	<p>Municipal waste, organic waste.</p>
<p>Nutrient level in water body</p> <ul style="list-style-type: none"> • Negligible • Low • High • Very high 	<p>Due to continuous discharge of the municipal waste, nutrient level i.e., eutrophication and organic pollution is very high in the water body</p>

Are local communities aware of the problem of water body	Yes
Are local communities interested in the restoration	yes
Any measures taken in past to restore the water body	No
Are there active local conservation group or NGO interested/involved in the water body	No
Is it possible to source good quantum of rainwater/treated water for maintaining water level throughout the year	Yes, abetting high rise residential society
Restoration activities require: <ul style="list-style-type: none"> • Improvement of water quality by in-situ treatment • Diversion and treatment of sewage waste • Desiltation for removal of toxic sediments • Weed removal • Catchment treatment to check erosion • Confinement of pond land 	<ul style="list-style-type: none"> • Improvement of water quality by in-situ treatment by diverting the sewage into the STP which can be built near the water body. • Catchment treatment to check erosion • Confinement of pond land
